METAL 2010

INTERNATIONAL CONFERENCE ON METAL CONSERVATION

CONSERVATION OF PIGEON CAMERAS: A COLLABORATIVE APPROACH BETWEEN CONSERVATORS AND SCIENTISTS

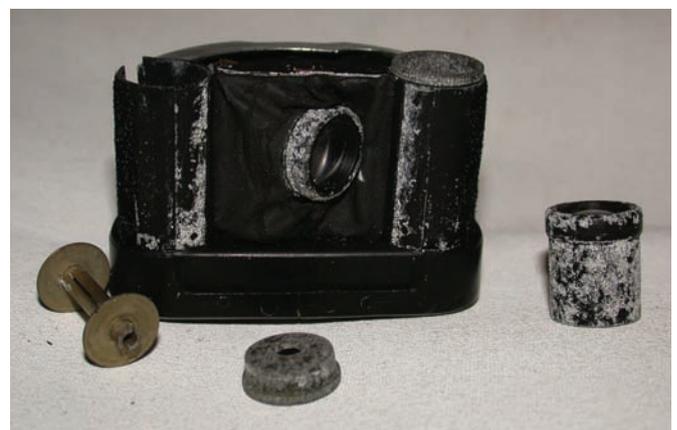
Figure 5. A pigeon camera, corroded objective and film reel before treatment. A thick white layer of corrosion is visible.

When examined, many of the cameras' parts appeared to be actively corroding with the corrosion spread over the entire camera (see Figure 5 and 8). A strikingly thick layer of white corrosion products were visible underneath the black paint and covered both the metal surface and the other materials associated with it. Another type of efflorescence consisting of light, microcrystalline powder seemed to affect only certain grey metal parts. A closer look revealed that these white corrosion products appeared only on components that were connected to other parts that appeared to be shiny and uncorroded.

After removal of the thickest corrosion layers mechanically, most of the remaining corrosion was removed by means of compresses containing a mixture of ammonium citrate, ethylenediaminetetraacetic acid (EDTA) and phosphoric acid. The last corrosion layers were then stabilised with sodium benzoate.

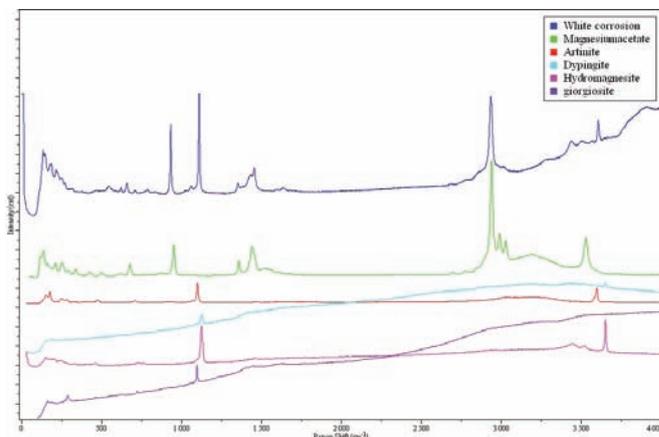
Figure 6. Raman spectra of the corrosion products analyzed from the cameras: unidentified white corrosion products and magnesium acetate were identified in 2006 (dark blue and green spectra), and artinite, dypingite, hydromagnesite and giorgiosite were identified in 2010 (red, light blue, pink and purple spectra), with a shift of circa +10 cm^{-1} due to the aging of the laser.

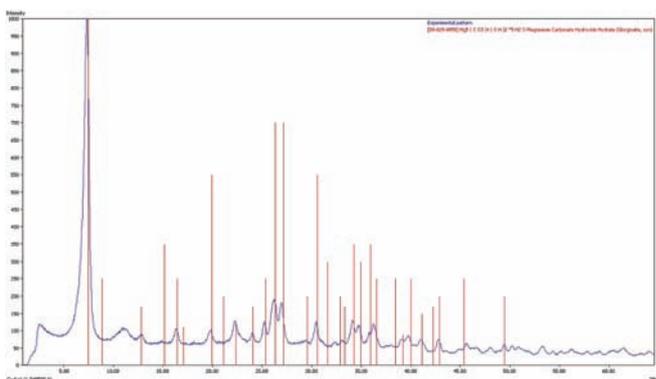
For this reason, more specific results were sought by X-ray powder diffraction (Stoe STADIP, $\text{Cu}_K\alpha$ -radiation, Ge-monochromator). The results showed that the thick white corrosion products were the same on all three parts of the camera (see Figure 7). This analysis did not detect magnesium acetate, most likely because of its non-crystallinity, but showed that the main component was in fact giorgiosite ($\text{Mg}_5(\text{CO}_3)_4(\text{OH})_2 \cdot 5-6\text{H}_2\text{O}$).

Figure 7. X-ray pattern of the thick white corrosion product, with major phase identification.

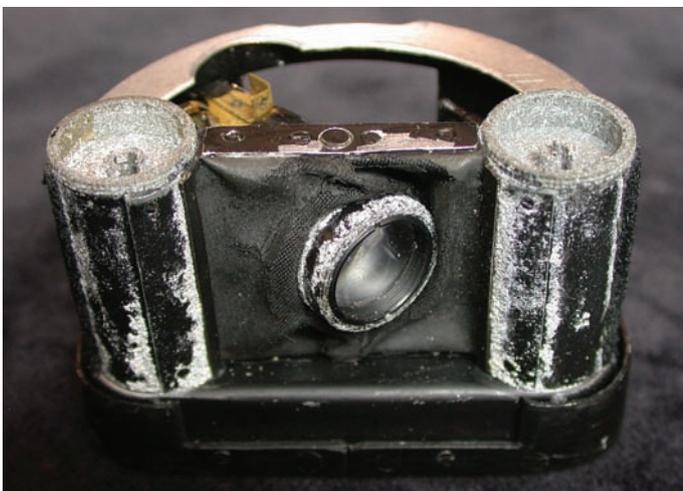
Figure 8. A pigeon camera before treatment

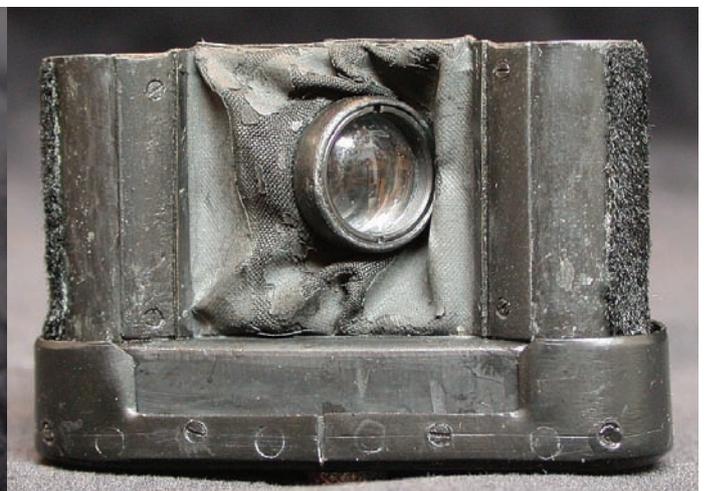
After conservation was complete (see Figure 9), the pigeon cameras were returned to the Swiss Camera Museum in Vevey and have been on exhibit there ever since with no corrosion problems noted (Berger 2008).

Figure 9. A pigeon camera after treatment

In order to protect the most sensitive components made of magnesium/aluminium and magnesium/zinc alloys from an aggressive environment (organic acid) and humid atmosphere, the surfaces were coated with 5% Paraloid B-72 in toluene. All moving parts of the camera were coated with mineral oil, and mineral wax was used to coat the static components.
